Filing Code 1525 (P-401)

July 1969

Bureau of Land Management U.S. DEPARTMENT OF THE INTERIOR

FORD TRUCKS - PARTS AND SERVICE RECOMMENDATIONS [Port]

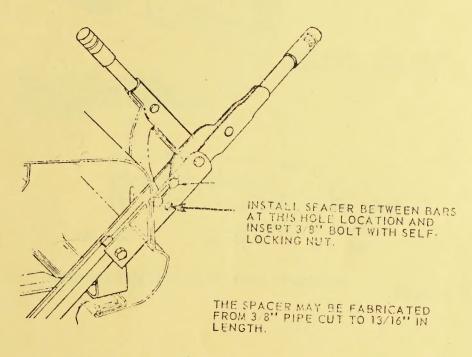
Figure 1 - Parking Brake Lever "C" Series

Effective September, 1968, the Orscheln parking brake lever on "C" Series trucks was revised by incorporating an additional spacer and rivet in the slot area between the two support bars. This change was made to reduce the possibility of the bars deforming if the parking brake lever is used as a grab handle when entering the cab.

The new lever is available for service under part number C5TZ-2780-B and can be identified by the presence of a rivet and spacer in the hole shown in Figure 1.

Parking brake levers on vehicles in service may be updated by inserting a spacer between bars and installing a 3/8" bolt and nut in place of the rivet used on production assemblies.

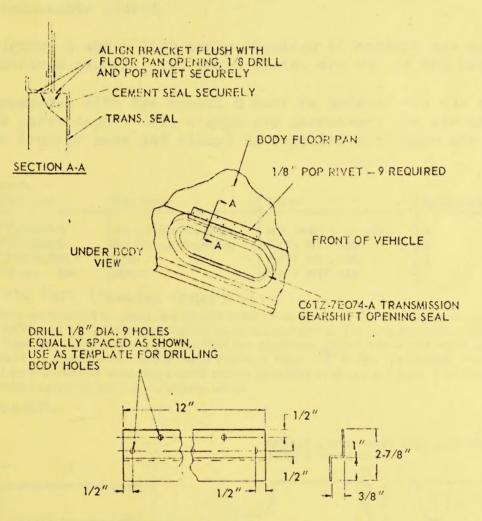
Figure 2

To correct water and dirt entry into the cab through the transmission gearshift lever opening when the seal is distorted, add a bracket to the underside of the body floor pan to provide additional support for the opening seal. Figure No. 2 includes all necessary information for fabrication and installation of the bracket.

A new opening seal, Part Number C6TZ-7E074-A, may also be required.

MATERIAL: 3-1/4" x 12" x 1/16" STEEL OR ALUMINIM

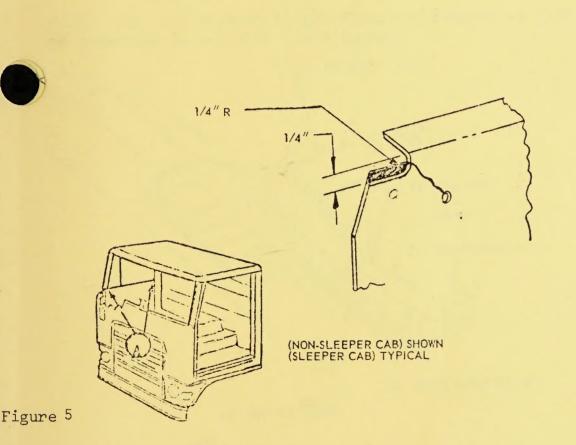
If sheet metal cracks occur at the front and rear belt relief notches of the door inner panels, the following procedure should be used. The production correction which enlarges the radius in the relief notches by removing metal from the vertical and horizontal trim lines was incorporated during July 1968.

ENLARGE AND RADIUS RELIEF NOTCHES BY REMOVING SHADED PORTION AS SHOWN. DRILL 1/8" DIA. HOLE AT TERMINATION POINT OF CRACK AND APPLY ARC WELD TO HOLE AND ENTIRE LENGTH OF CRACK.

- 1. Remove the door inner upper panel as described in the 1968 Truck Shop Manual, Volume Three, Page 17-54.
- 2. Drill a 1/8" diameter hole at the termination point of the sheet metal crack.
- 3. Enlarge and radius the front and rear belt relief notches on the door as shown in Figure 5.
- 4. Apply arc weld to the drilled holes and the entire length of the cracks.
- 5. Metal finish and repaint the repaired area as required.

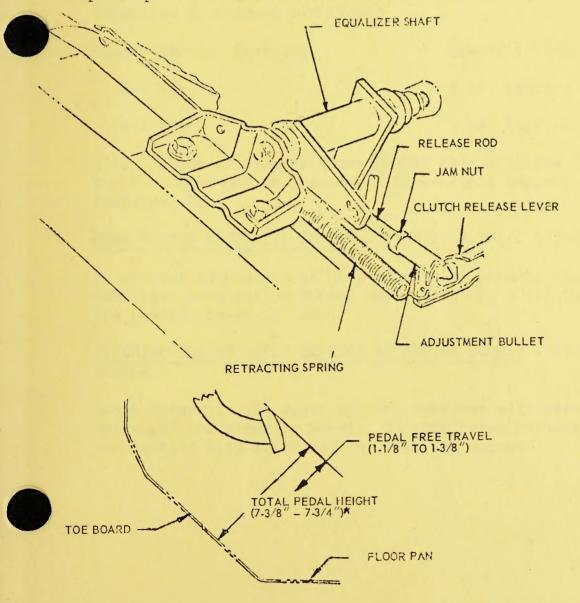
Figure 6

The clutch pedal "free travel" at the release rod "bullet" has been revised to .200 inch. To correctly adjust "free travel" follow this procedure:

NOTE: The clutch pedal height dimension remains at 7.38" - 7.75". Free travel at pedal pad is 1-1/8 to 1-3/8 inches.

* Mat/Carpet and/or Insulation must be folded out of way. Measure to sheet metal, perpendicular to toe board.

- 1. Make sure the retracting spring is attached to the clutch release lever.
- 2. Loosen jam nut and back off five (5) or more turns.
- 3. Turn release rod "bullet" lightly against the clutch release lever facing. Use caution not to force "bullet" against the clutch release lever causing it to move against the retracting spring.
- 4. Place .200" gauge between the release rod "bullet" face and jam nut.
- 5. Return jam nut against gauge.
- 6. Remove gauge.
- 7. Hold jam nut in this position and rotate release rod "bullet" against the jam nut and tighten. (Torque specification is 12/18 ft.lbs.)
